# Manhole Inspection Summary

## Manhole # S13CC1025MH

Insp Date: **6/20/07 1:51 PM**

**Location** Address: **2800 KEYWORTH AVE**

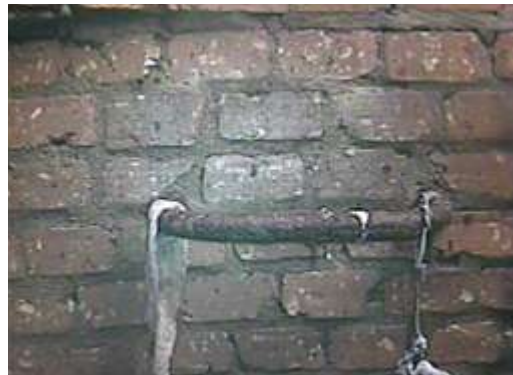
Defect 1

☒ **Evidence Of Surcharge** Depth: **4** (ft.) ☐ Active Surcharge Present

SURCHARGE

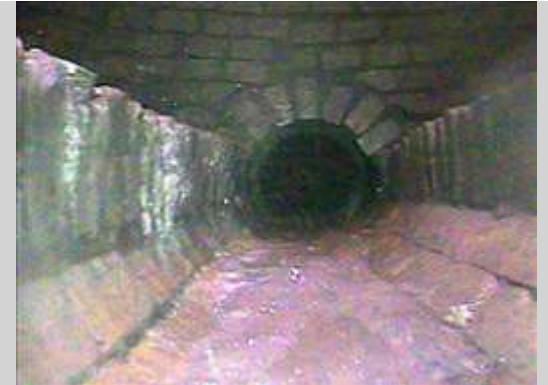
12 O'Clock Outflow

12 in. Circular Gravity Sewer  
Pipe Out @ 12 O'Clock

Pipe Height: (in.) Direct  
Pipe Material: **Clay** ☐ Pipe Lined  
Invert Depth: **9.55** (ft.) Flow Characteristics: **Fast**  
Deposits: ☒ None ☐ Mud ☐ Sludge ☐ Debris ☐ Grease  
Silt Depth: (in.) Deposits Extent:  
Infiltration: **None** Pipe Seal Cond: **Sound**

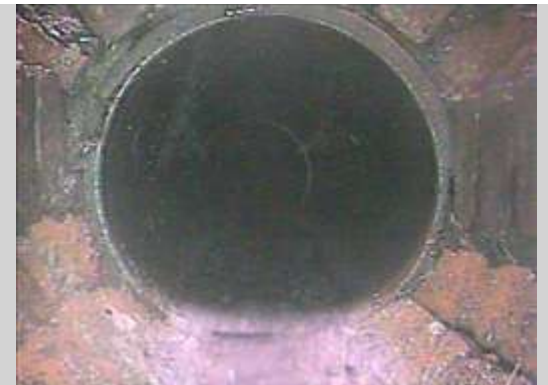
6 O'Clock Inflow

12 in. Circular Gravity Sewer  
Pipe In @ 6 O'Clock

Pipe Height: (in.) Direct  
Pipe Material: **Clay** ☐ Pipe Lined  
Invert Depth: **9.39** (ft.) Flow Characteristics: **Fast**  
Deposits: ☒ None ☐ Mud ☐ Sludge ☐ Debris ☐ Grease  
Silt Depth: (in.) Deposits Extent:  
Infiltration: **None** Pipe Seal Cond: **Sound**

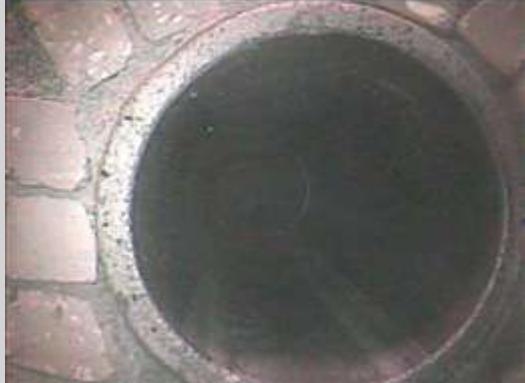
9 O'Clock Inflow

8 in. Circular Gravity Sewer

Pipe In @ 9 O'Clock

Infiltration: **None** Pipe Seal Cond: **Sound**
